Specification	
Stock No	357891
Type	REACH
Make	LINDE
Model	R14 115
Year	2002
Euromast	3F630
Hours	2363
Capacity	1400 kg
Lift height	6295
Values	
Quality Rating	0
Mechanical	
Character.	
Load Centre (c)	600/500 mm
Operating mode (Characteristic)	Seated
Wheelbase (y)	1275 mm
Load distance (x)	311 mm
Weights	
Service weight (Total weight)	3094 kg
Axle load with load (front/rear)	1800/1090 kg
Wheels	
Tyres type	Polyurethane
Tyre size front	285 x 100 mm
Tyre size rear	343 x135 mm
Track width rear (b11)	1150 mm
Wheels (front/rear (x=driven))	1x/2
Dimensions	
Mast or fork carriage tilt (alpha,beta)	2/4 grad
Free lift (h2)	2070 mm
Lift height (h3)	6295 mm
Extended height (h4)	7335 mm
Height of overhead guard (cabin) (h6)	2110 mm
Height of reach legs (h8)	310 mm
Overall length (l1)	2384 mm
Length to fork face (l2)	1184 mm
Overall width (b1/b2)	1234/1250 mm
Forks length (l)	1000 mm
Fork carriage (class)	DIN 15173 / 2A
Fork carriage width (b3)	830 mm

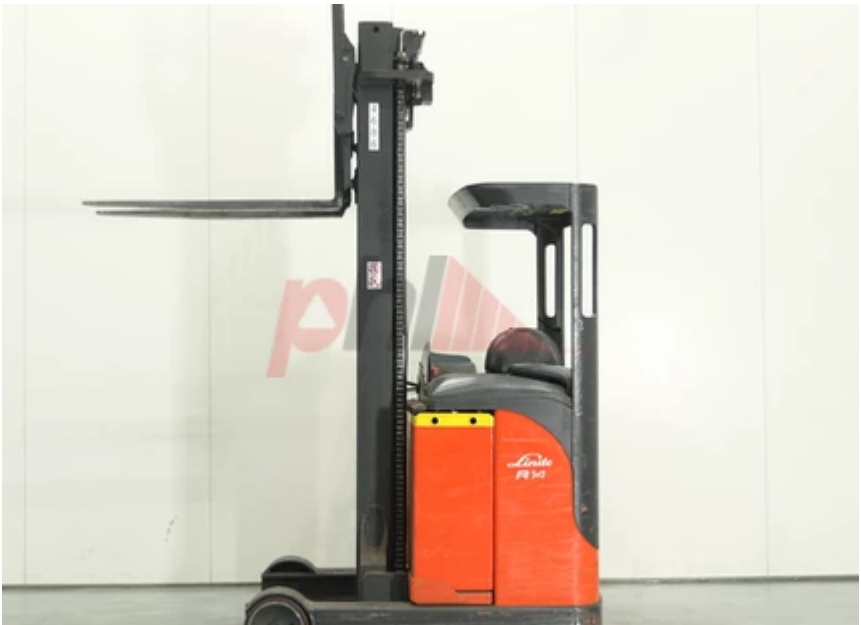
Appearance: Very good appearance for age.

Mechanical Status: Good Mechanical Condition
