Stock No 336933 GAS Туре Make LINDE Model H18T 350 Year 1999 Euromast 2F350 Hours 9752 Capacity 1800 kg Lift height 3500 Values Quality Rating 0

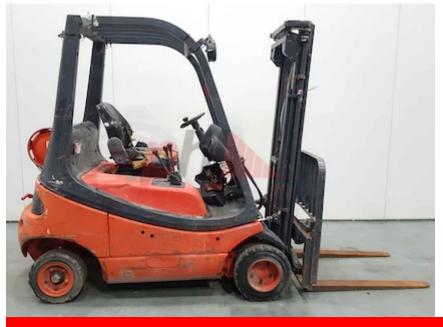
Tyres type Superelastic Tyres front condition 20% Tyres rear condition WORN Tyre size front 200/50-10 mm 18X7-8 mm Tyre size rear Track width front (b10) 945 mm Track width rear (b11) 873 mm

Appearance: Average appearance for the year.

Mechanical Status: Good working condition
